# **FINAL REPORT**

## **Demonstrate a Low Biochemical Oxygen Demand Aircraft Deicing Fluid**

**ESTCP Project WP-200905**

**March 2013**

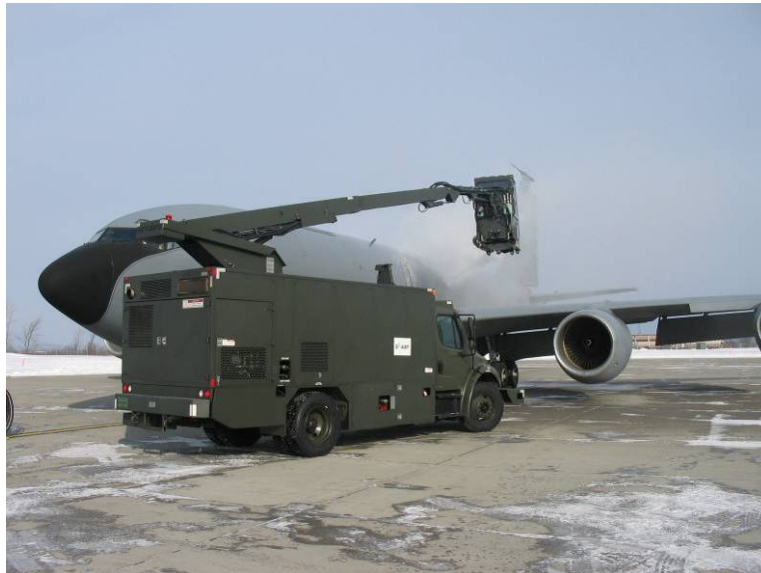
The basic requirement of a deicing fluid is to transfer heat to frozen aircraft surfaces to either melt the frost, or de-bond the frozen ice or snow allowing it to run off the aircraft leaving the surface free of frost, ice and snow. The fluid is heated to approximately 180°F to increase the melting/ de-bonding effectiveness. Also, pressurized application of the fluid provides mechanical force to abrade and dislodge frozen substances. It is critical that the fluid contributes to freezing point depression when mixed with the melted contamination so that nothing will refreeze on the aircraft. A picture of a typical deicing operation can be seen in Figure 1.

**Figure 1 Typical Deicing Operation**

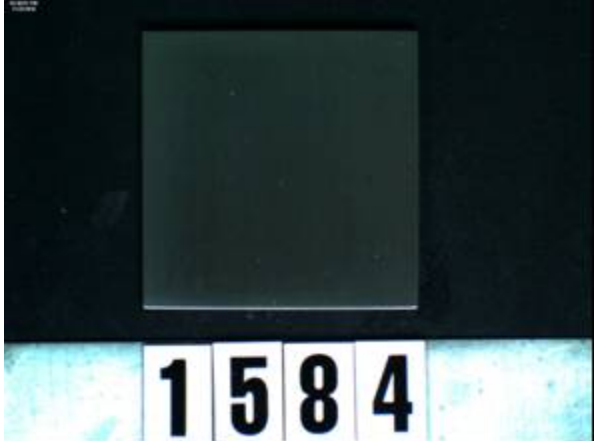
Substrate Material	Photo
4140 Steel

**Table 5. Alternate Immersion Photos – After Exposure**

Test results from Type I Octaflo deicer from a previous testing effort was reviewed and compared to this data. The PG deicer also had little to no effect on these metallic substrate materials.

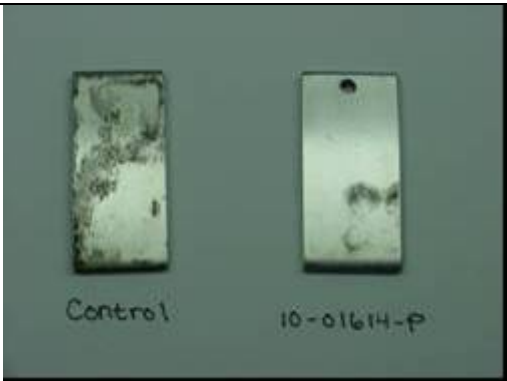
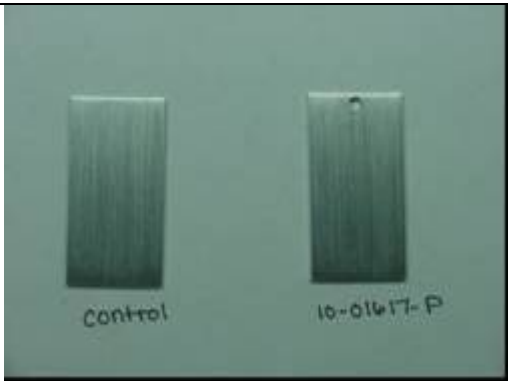
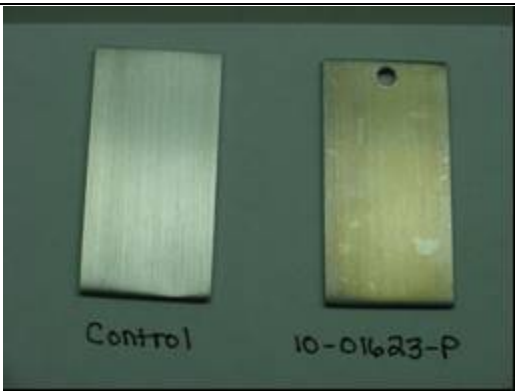
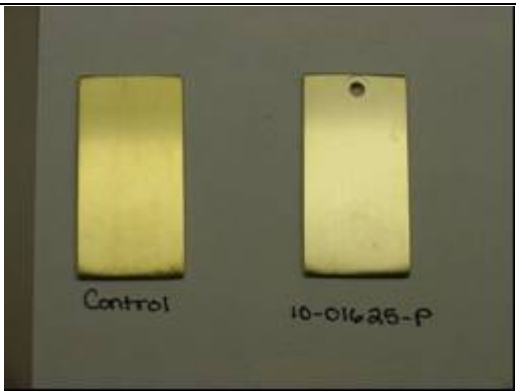
The EcoFlo deicer appeared to have minimal effect on the various metallic materials. All materials exhibited less than 0.5% change in weight when exposed to the deicing solution.

4140 Steel		7075-T6 Aluminum (Bare)

AZ91E-T6 Cast Magnesium Alloy		C99300 Aluminum-Bronze Alloy

**Figure 1. Photos of Metallic Materials after 168-hour Immersion**

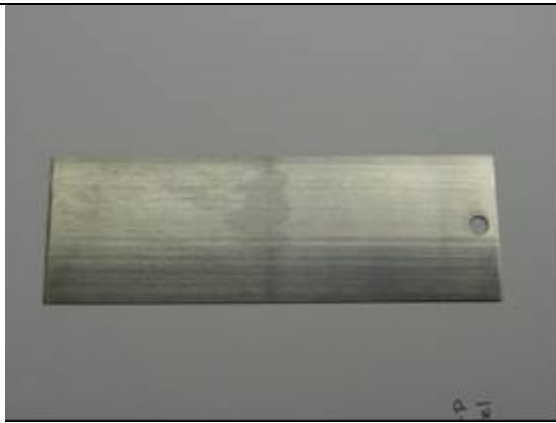
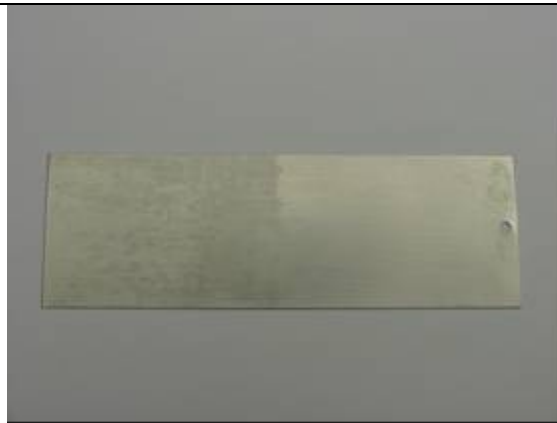
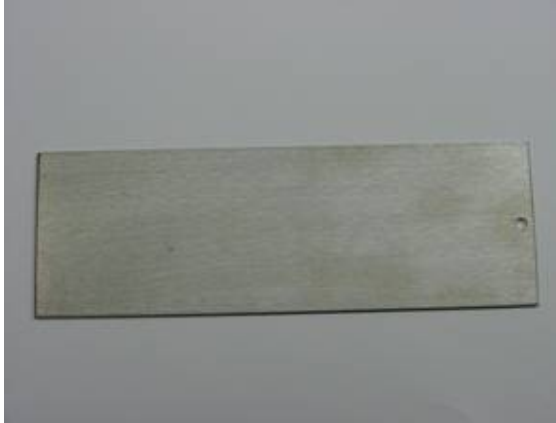
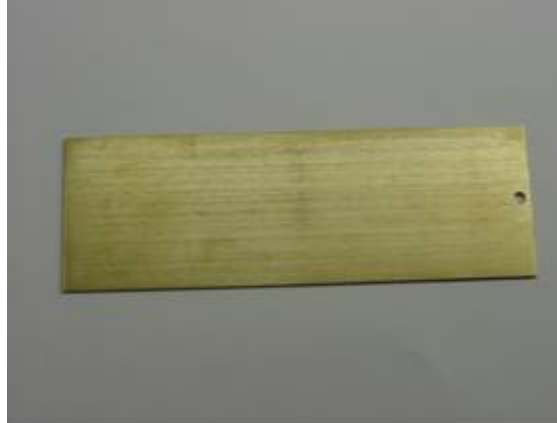
Substrate	Test Result
4140 Steel	PASS – slight staining
7075-T6 Aluminum (Bare)	PASS – slight staining
AZ91E-T6 Cast Magnesium Alloy	PASS
C99300 Aluminum-Bronze Alloy	PASS – slight staining
Titanium 6Al-4V	PASS – slight staining

4140 Steel	7075-T6 Aluminum (Bare)

AZ91E-T6 Cast Magnesium Alloy	C99300 Aluminum-Bronze Alloy

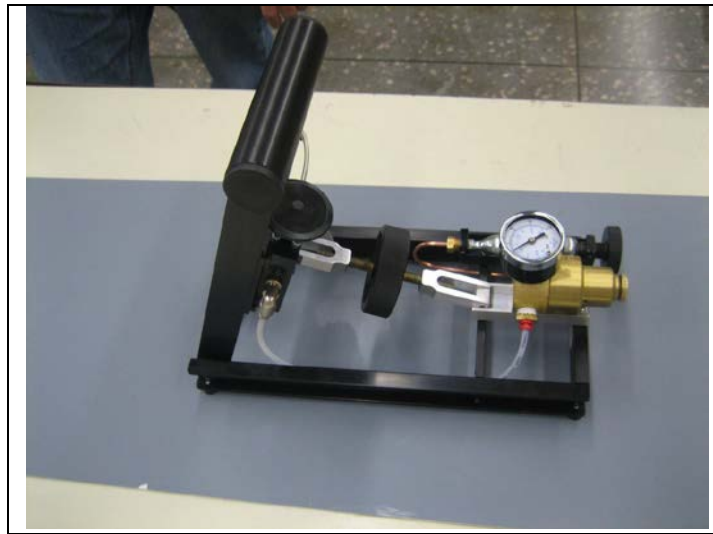
The English XL Variable Incidence Tribometer (VIT) (Figure 2) is a portable device featuring a 1.25 inch diameter Neolite (a once common rubber heel and sole material for shoes) test foot. The Neolite disk is mounted on a piston which can be extended with a consistent and repeatable force by regulated feed of pressurized gas from a small CO<sub>2</sub> canister. The operator can vary the impact angle (angle at which the test foot approaches the test surface) using an adjusting knob on the VIT.

**English XL Variable Incidence Tribometer (on painted aluminum test panel at AMIL)**

Once contact with the surface occurs, the test foot can pivot freely and the piston can rotate about the axis at the top of the device. The measurement of slipperiness provided by the VIT is a Slip Resistance Index (shortened, for convenience, to “Slip Index”). The manufacturer defines the Slip Index as the tangent of the angle between the test foot impact direction and the normal to the test surface. The manufacturer’s working range for the Slip Index is 0 to 1, with 0 equivalent to a 0° impact (basically walking in place) and 1 representing a 45° impact (a very large stride).

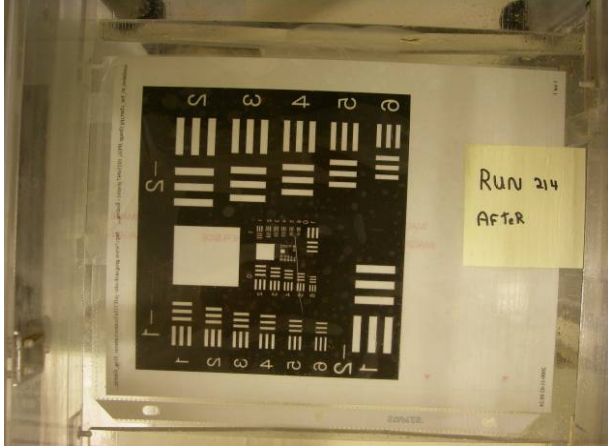
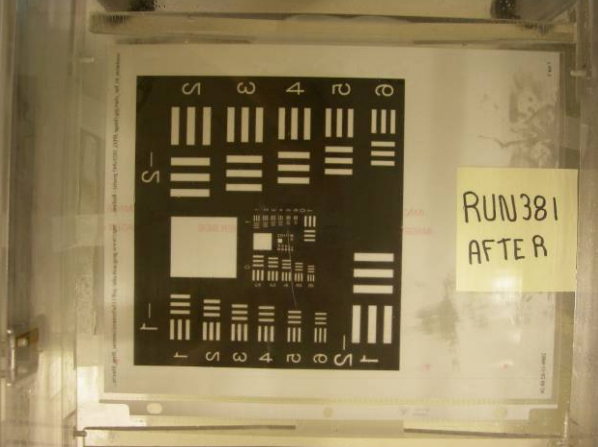
While the wind tunnel configuration may not duplicate all conditions for transparencies on military aircraft (e.g., the parallel airflow in the wind tunnel test section is likely not similar to the airflow experienced by a boom operator’s window on a KC-135), it should be noted that when a uniform residual thickness of fluid was detected and the test rerun for a longer duration, there is no significant difference in clarity of the eye chart in the photos. This can be seen in the photograph for Run 214, in which residual fluid was detected in the test duct after a 5 minute test run, in comparison to the photograph for Run 381, in which there was no measurable fluid thickness after a 10 minute run (Figure 4). This indicates that a measurable but uniform thickness of fluid seems to have no impact on visual resolution.

<p>Wind Tunnel Temperature: 0°C  H<sub>2</sub>O Reduction Before Test: 0%  Initial Fluid Thickness: 1 mm  Wind Tunnel Run Time: 5 minutes (Fluid Detected)</p>	<p>Wind Tunnel Temperature: 0°C  H<sub>2</sub>O Reduction Before Test: 0%  Initial Fluid Thickness: 1 mm  Wind Tunnel Run Time: 10 minutes</p>

**Visual Comparison Between Some Fluid / No Fluid Remaining (EcoFlo Fluid Test)**
